Sweep Frequency Response Analyzer

PFRS-25

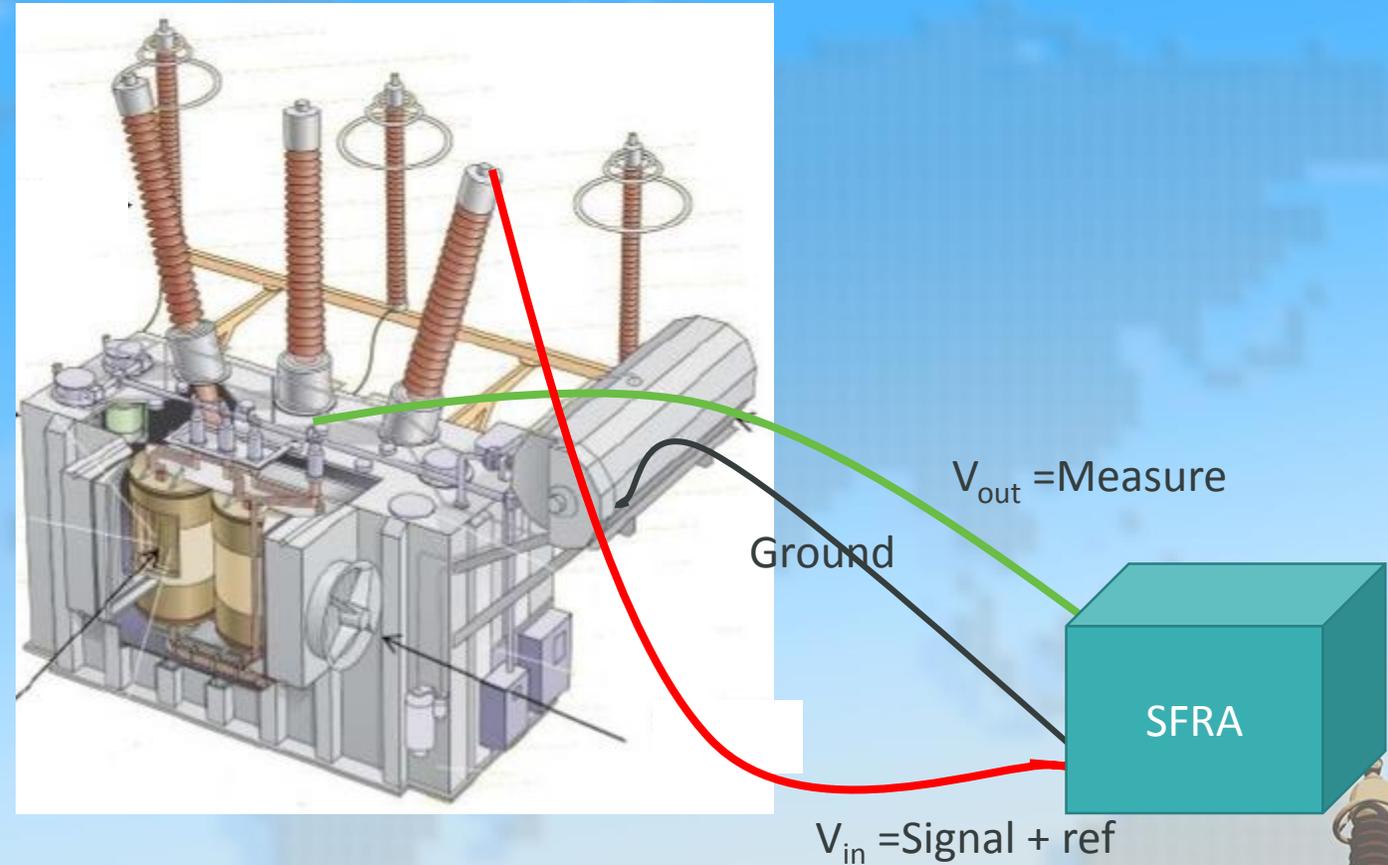
FRA Test

Injects voltage of different frequencies in to the winding of transformer : V_{in}

Measures the voltage at the other end of winding of the transformer : V_{out}

Plots the Mag (dB) = $20 * \log_{10} V_{out}/V_{in}$

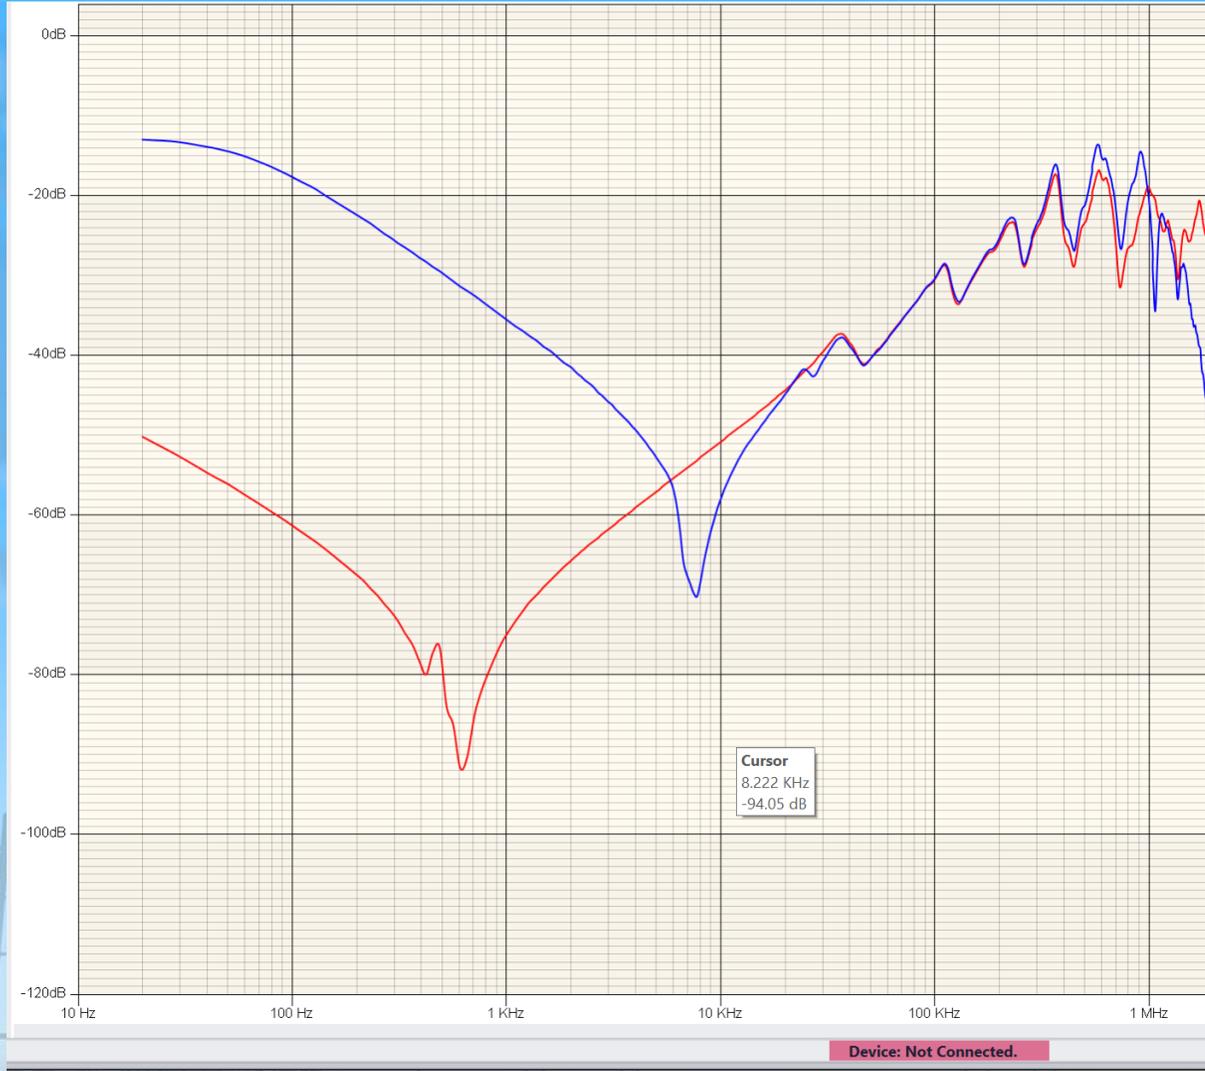
Typical FRA Measurements: 10 Hz to 2 MHz

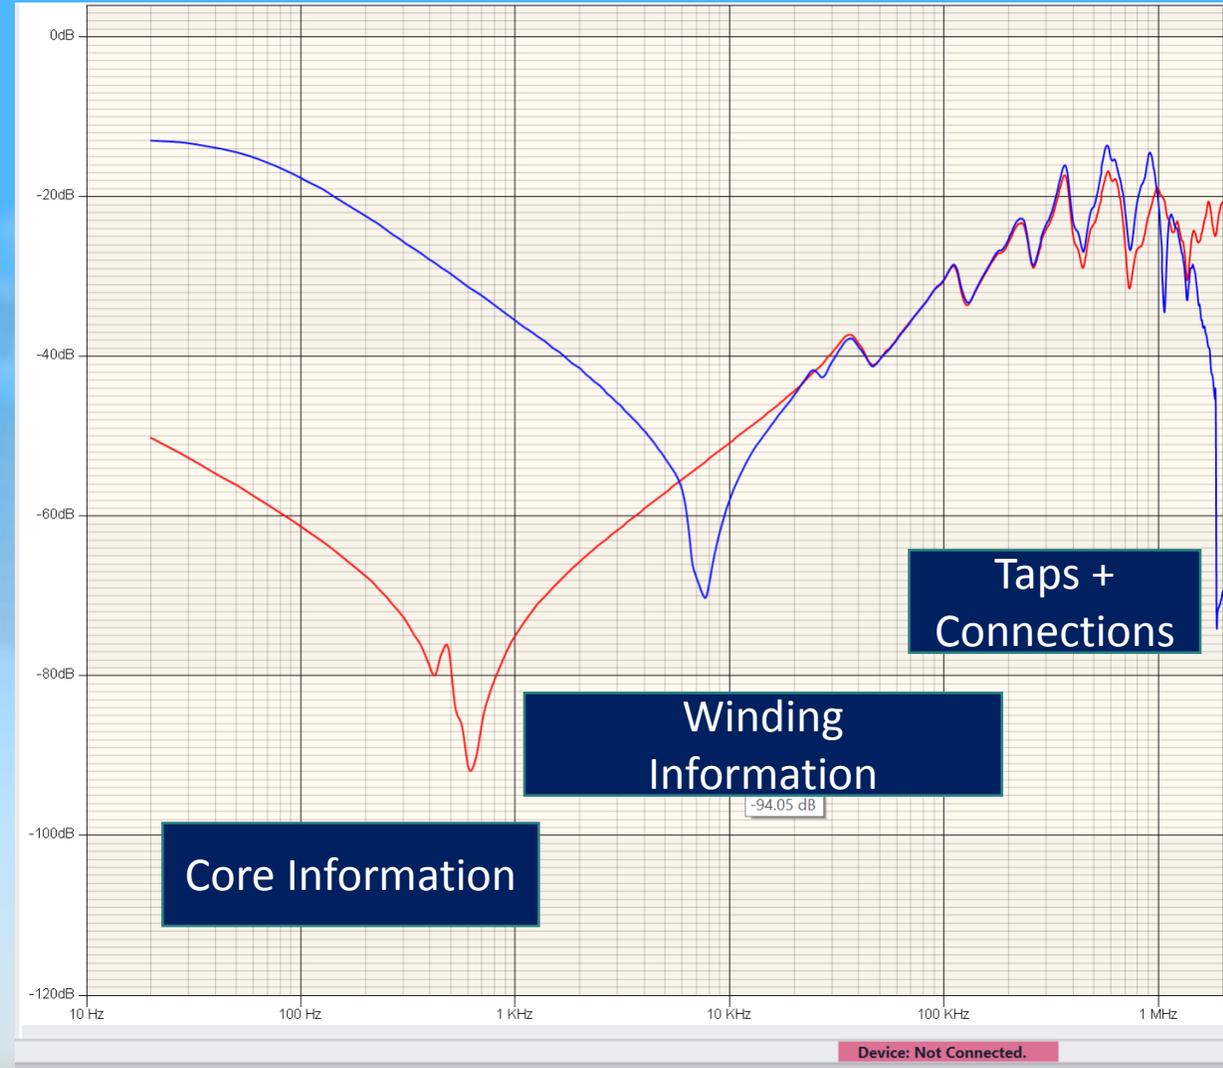
FRA Trace: Transformer Diagnostics

Transformer elements visible in different parts of the sweep

Low frequencies

- Core problems
- Shorted or open windings

Medium frequencies

- Winding deformations

High Frequencies

- Connections
- Taps and other connection changes

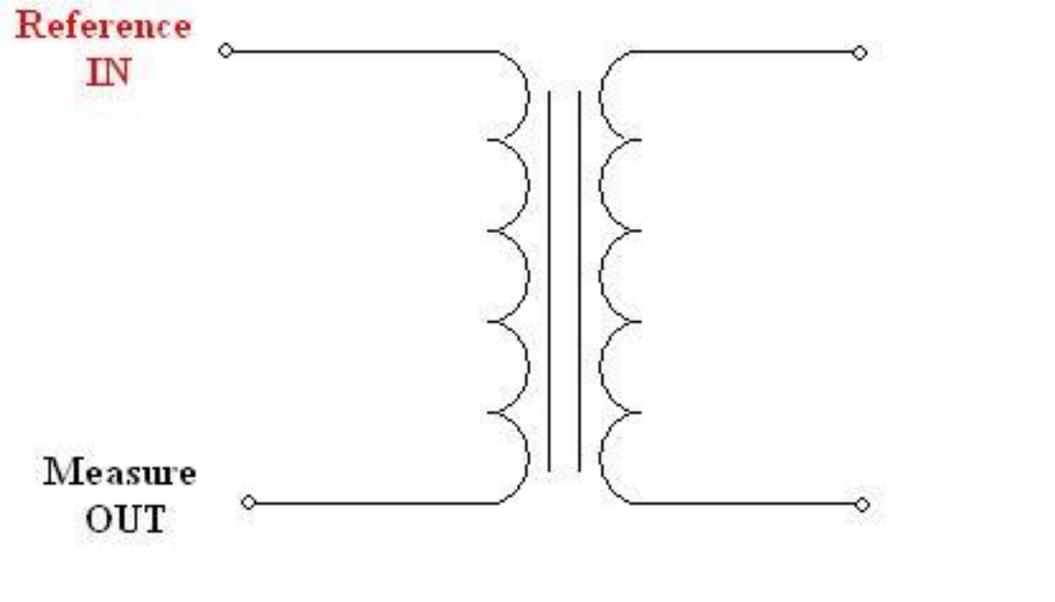
- Open Circuit Test : “Reference IN” at one end of a winding and “Measure Out” at another end with all other terminals floating.
- Open Circuit Self-Admittance tests : Primarily influenced by the core properties at or around the fundamental power frequency

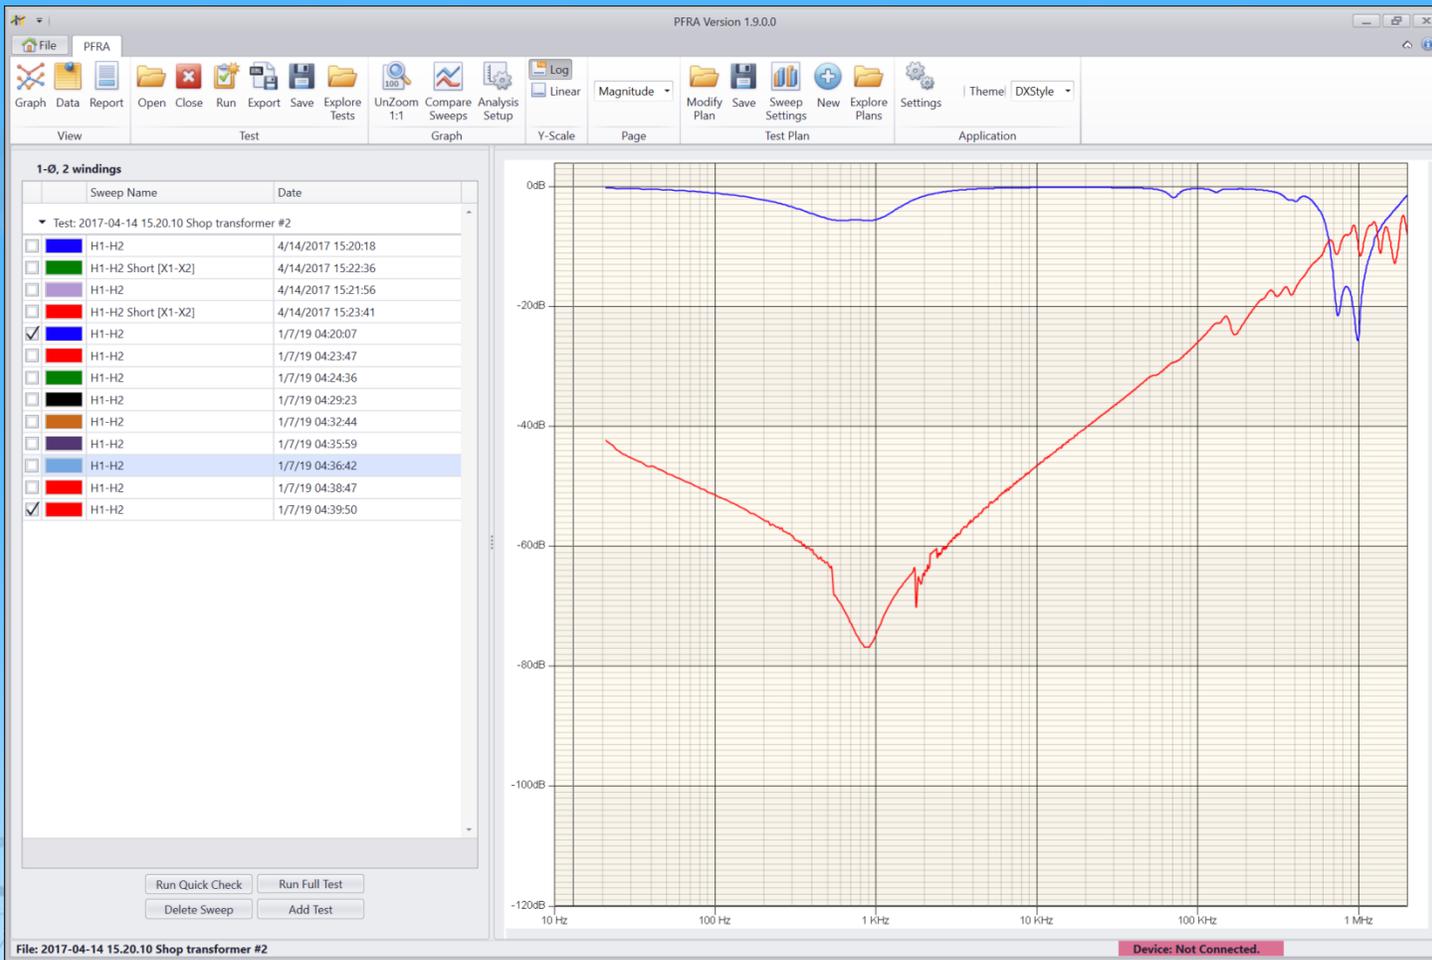
Transformer Fingerprint

- End to End (OC) tests characterizes magnetizing impedance in the low frequency region
- Each winding separately can be examined
- Common test due to simplicity

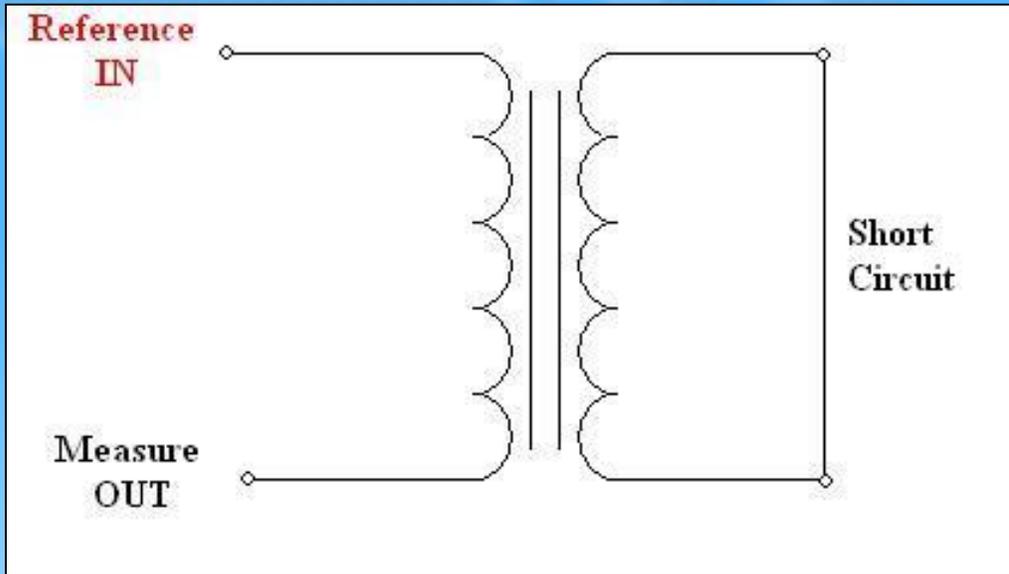
Short Circuit Test (SC)

- A Short Circuit Self-Admittance measurement: "Reference In" at one end of a high voltage winding to "Measure OUT" at the other end with low voltage winding shorted.
- The Short Circuit Self-Admittance test isolates the winding impedance from the core effects properties at or around the fundamental power frequency.

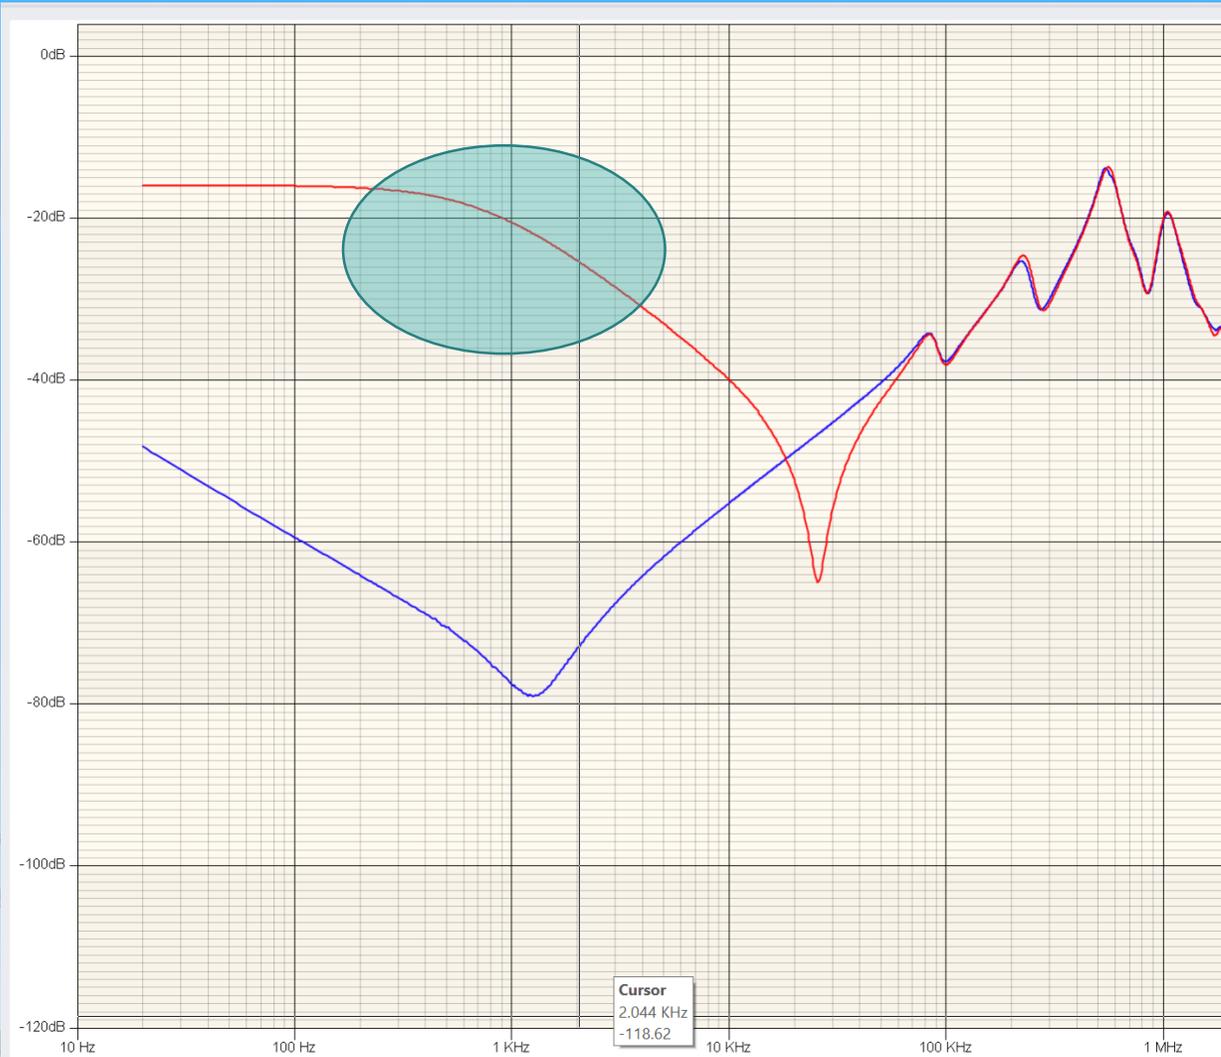
Short Circuit Sweep Vs. Open Circuit Sweep

Blue Trace Open circuit test

Red Trace Short Circuit test

Higher freq. identical response

SC Test : Isolates effect of core

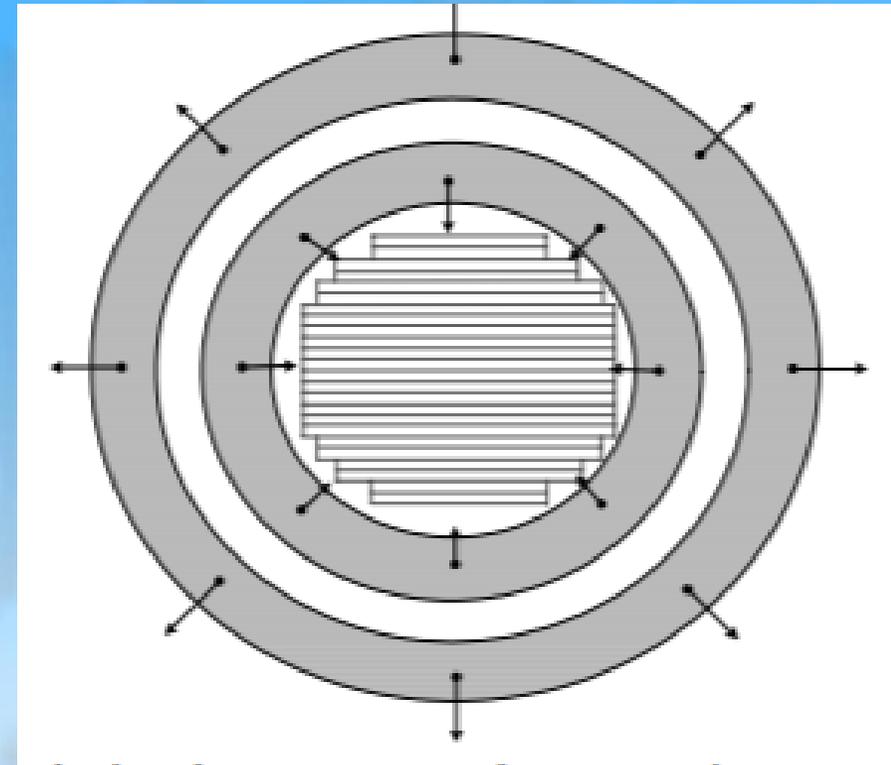
Winding Deformation : Hoop Buckling

Short circuit current in the transformer produces hoop stresses on the windings.

Inner windings (LV) produces compressive forces while outer winding (HV) produces hoop stress

The force is proportional to $(NI)^2$

Short circuit current also produces axial forces trying to expand winding axially

These stresses deforms the windings and weakens the holding structure

RLC components changes once the windings are deformed

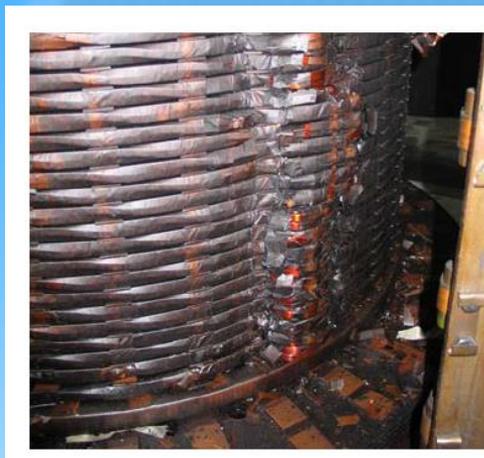
Radial Buckling

- Through fault current some time 20 times the load current, creates axial and radial forces which can deform the windings
- The typical results of these forces :

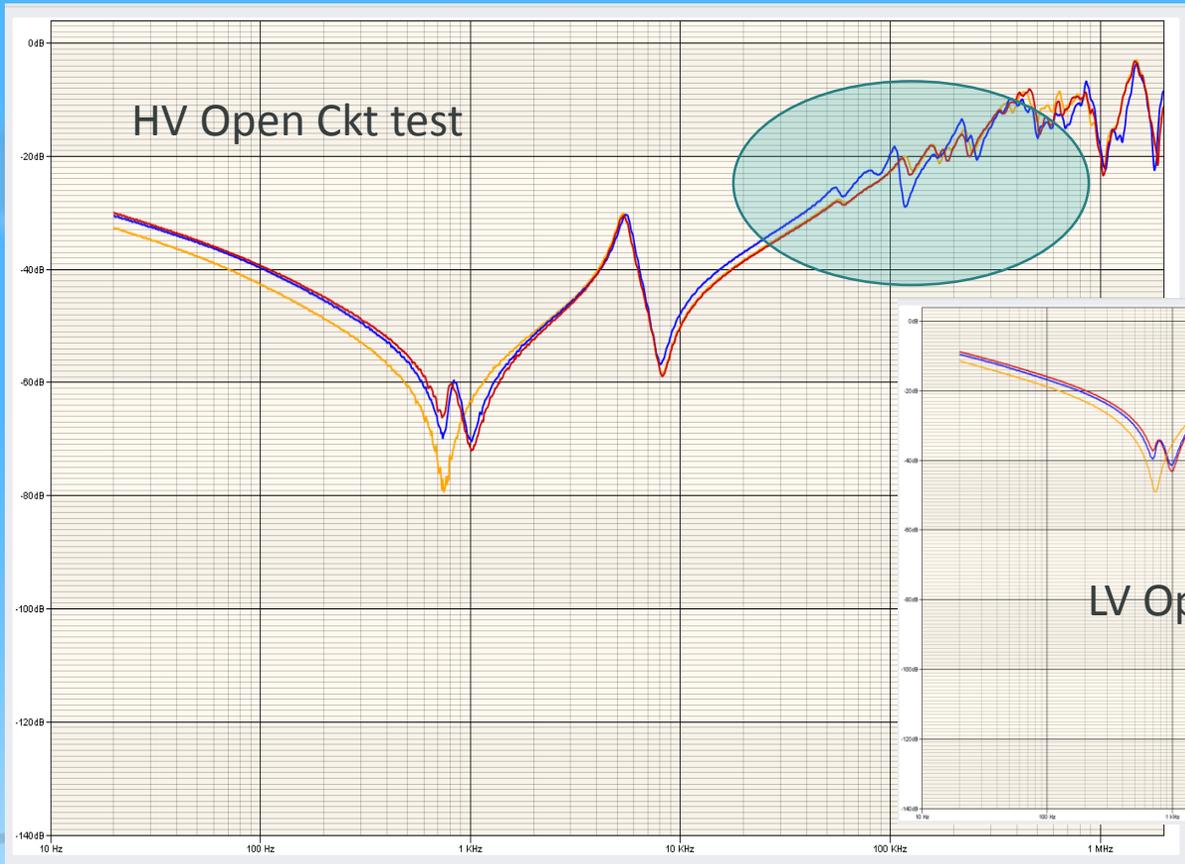
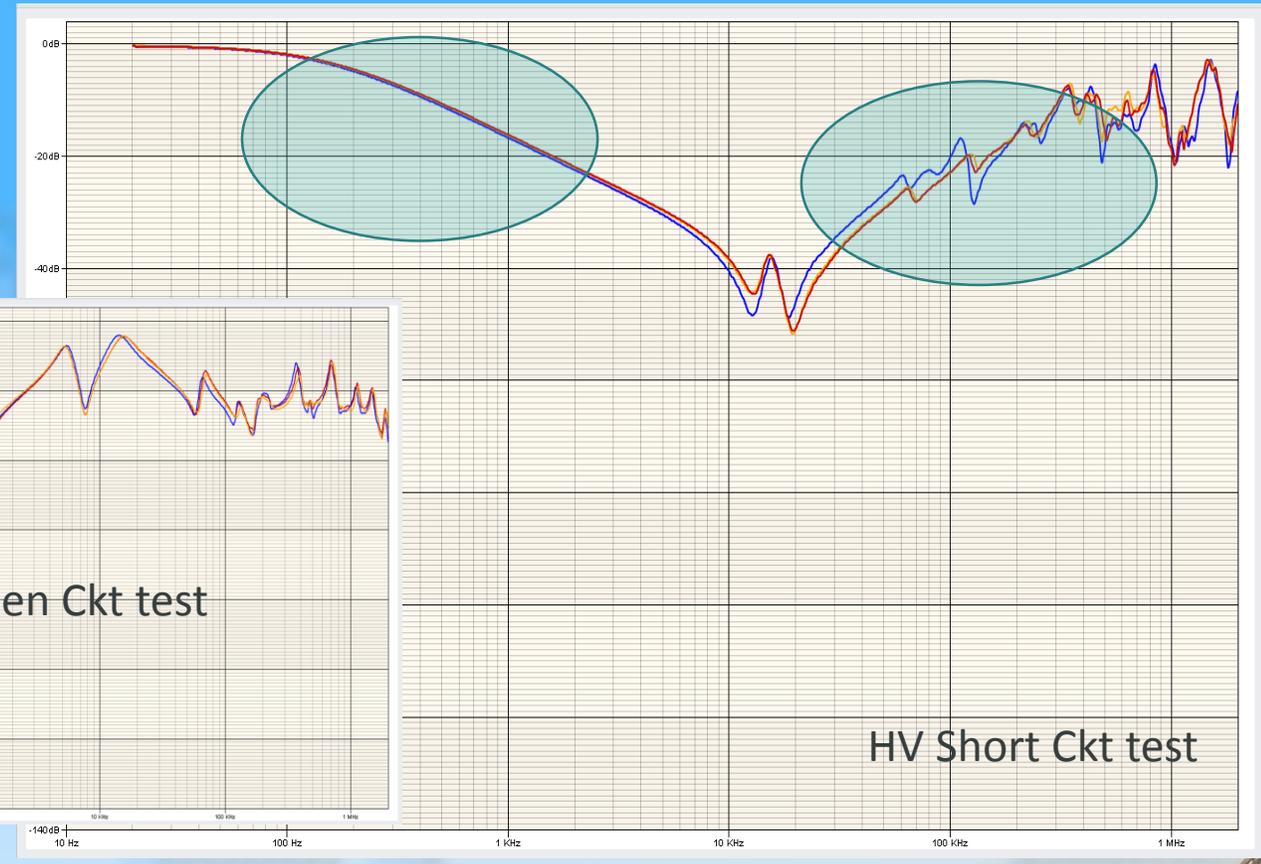
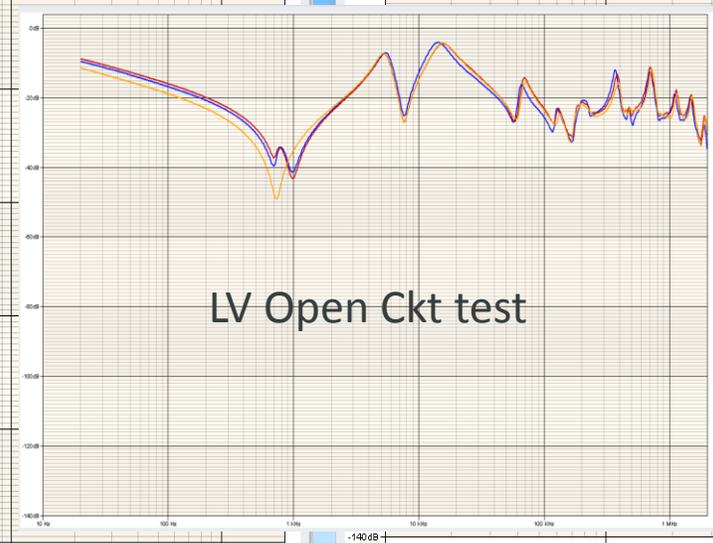
Winding Deformation Case

Open Circuit Test shows winding shift left (Blue trace)
Leakage reactance results showed a problem in the phase

Short Circuit Test shows increased impedance in one phase

- HV phase is showing variations at 100KHz
- LV phase is moving towards lower frequency
- Increased LC components indicating minor winding deformation and/or hoop buckling
- Recommended that the transformer be internally inspected

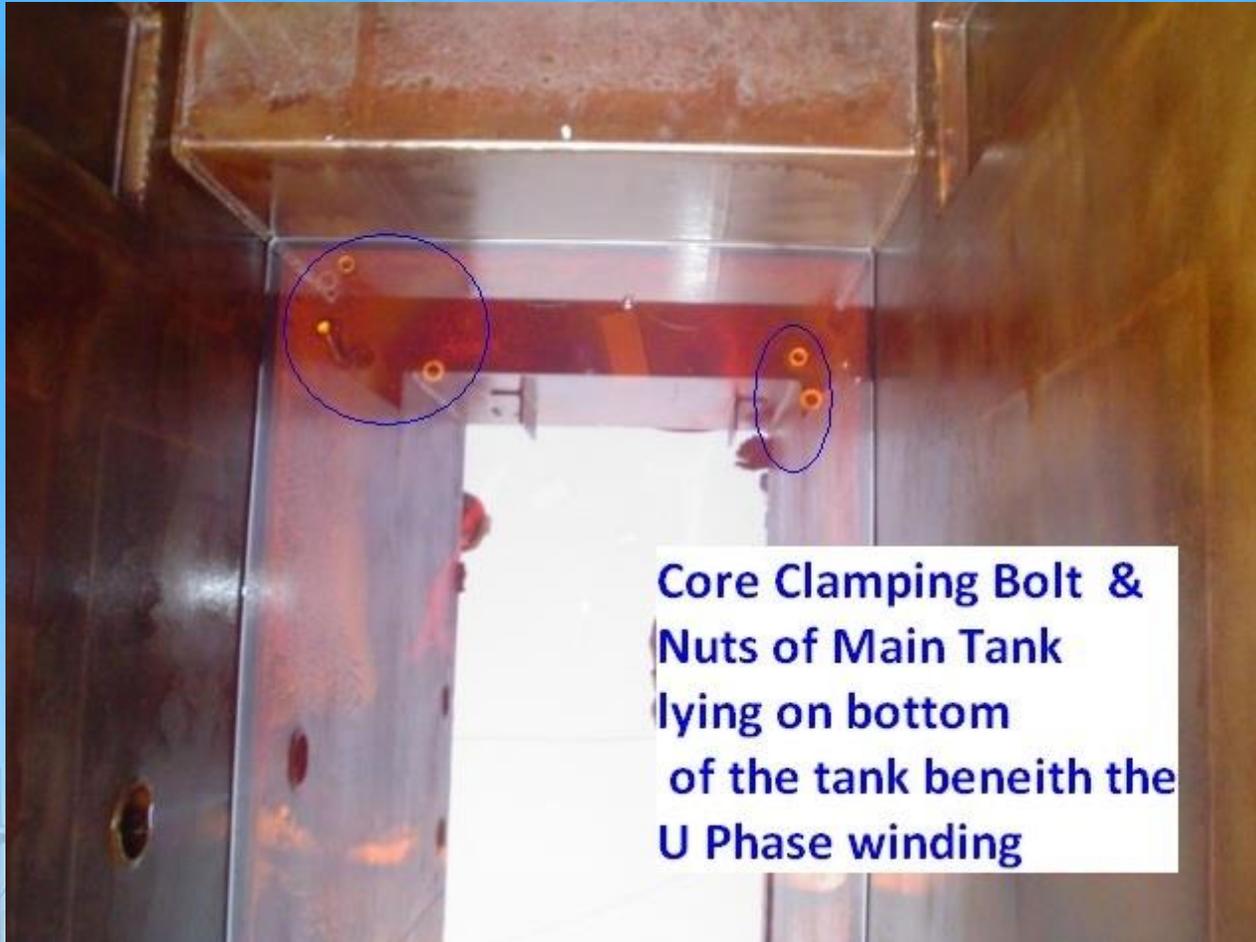
Core Clamping Bolt & Nuts of Main Tank lying on bottom of the tank beneath the U Phase winding

- Core clamping bolt and nut got welded to the core created hot spot
- Indicated by DGA

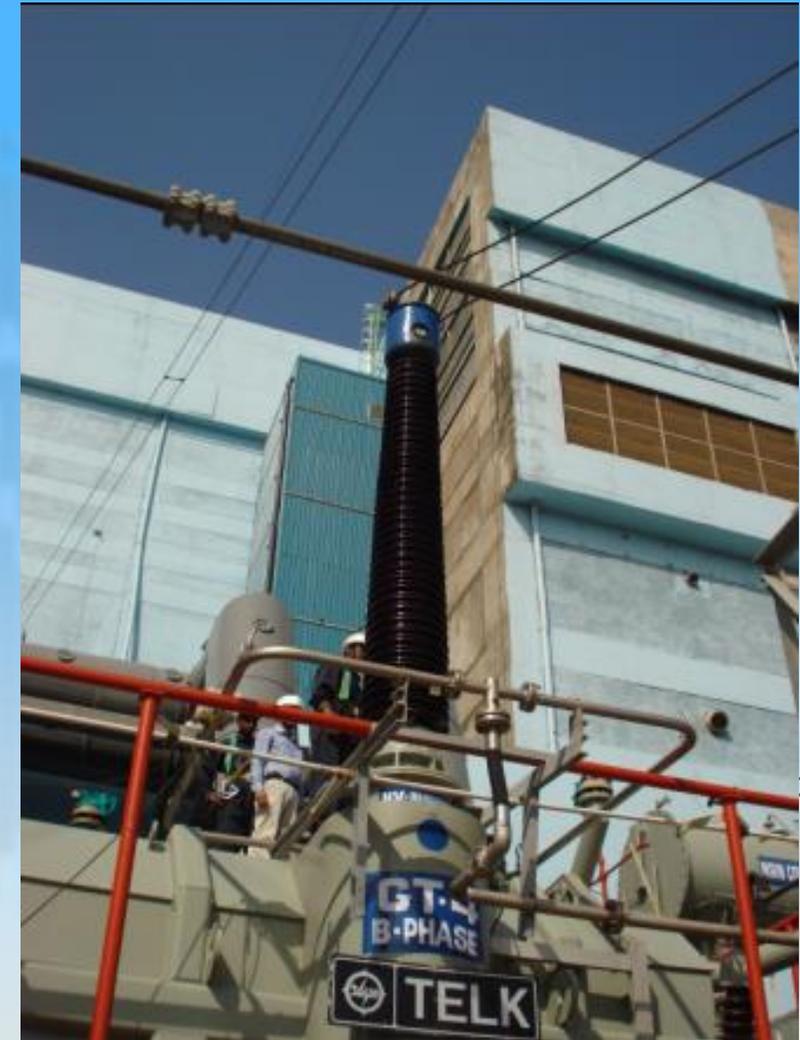
Case Study : Core Magnetization

- Single phase GSU : 630 MVA 420 kV/21 kV
- Unit Tripped on flash over on C phase
 - Differential protection operated and fault current recorded was 36KA
- SFRA test performed
 - 3 other sister transformers were also tested (3 ph & 1 spare)

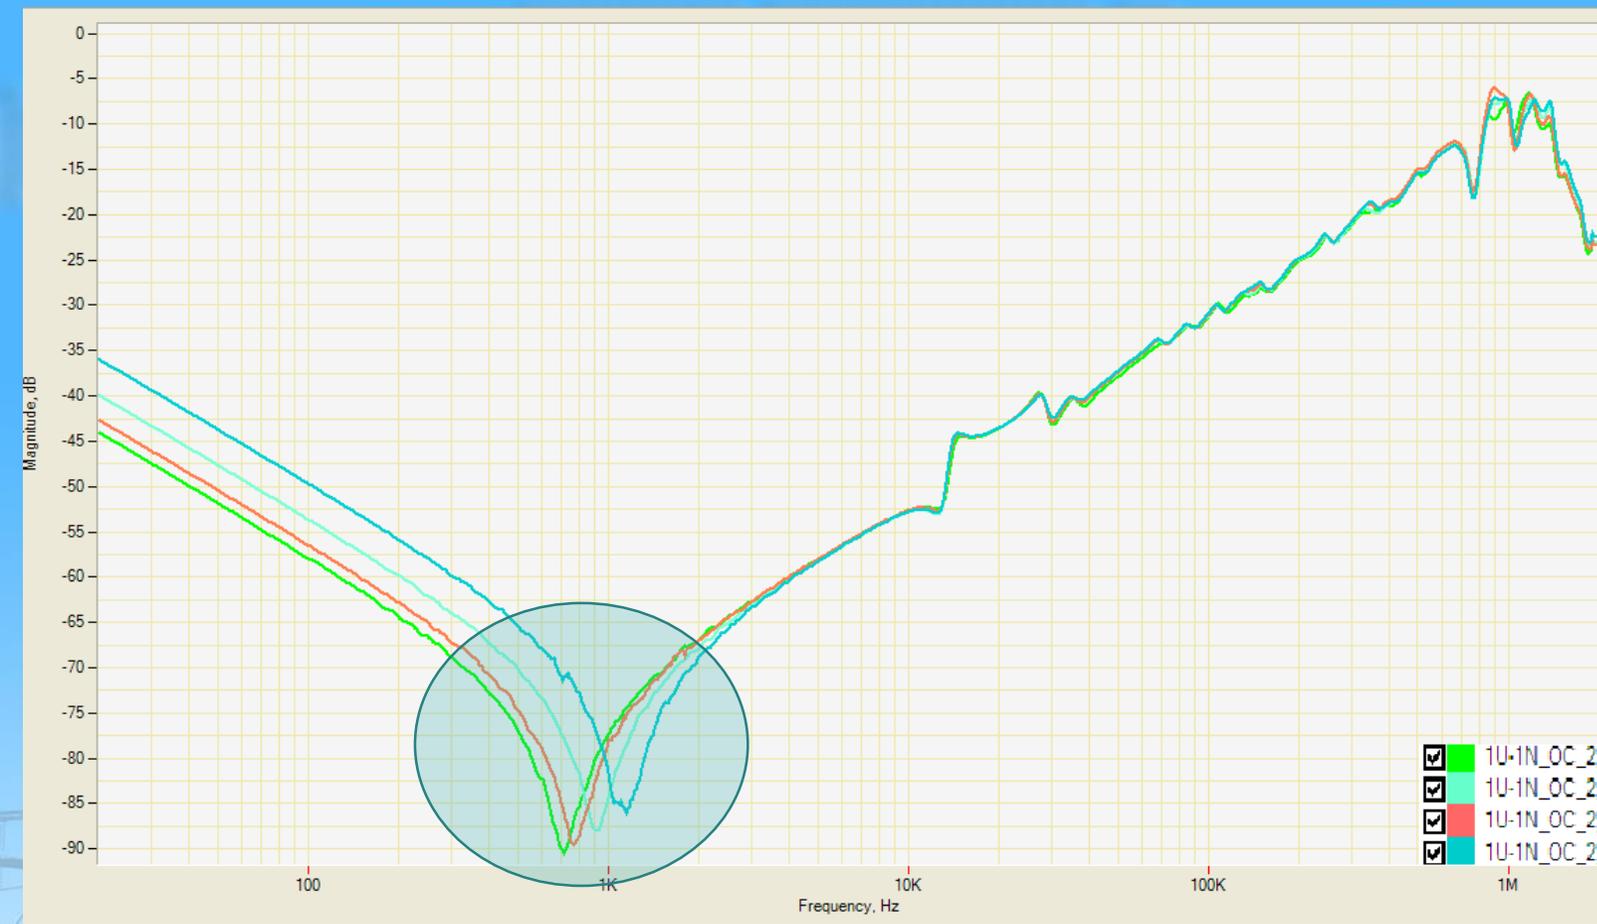
SFRA : 4 identical Units

- Core resonances are shifted to right
- Reason : core magnetization
- All other windings matches well
- No damage to the transformer
- Confirmed by SFRA
- Demagnetize the transformer to put it back in service

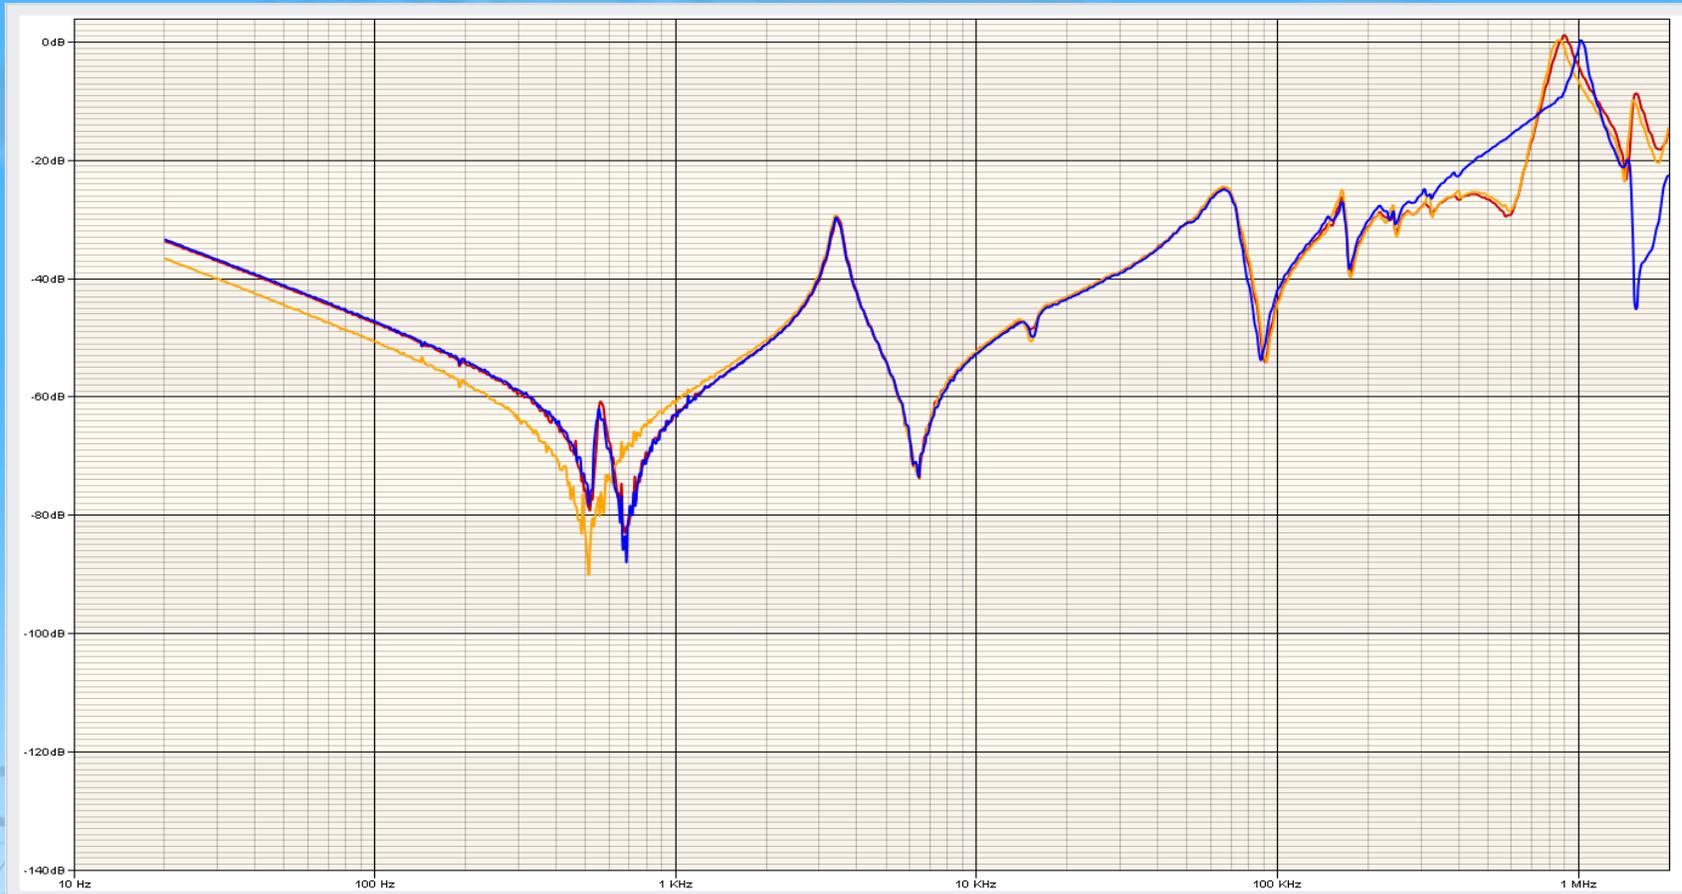
- 230/33 kV YNYno 125 MVA
- Routine SFRA testing in 2017
- Blue Trace in HF region is not matching with other phases indicates termination problem

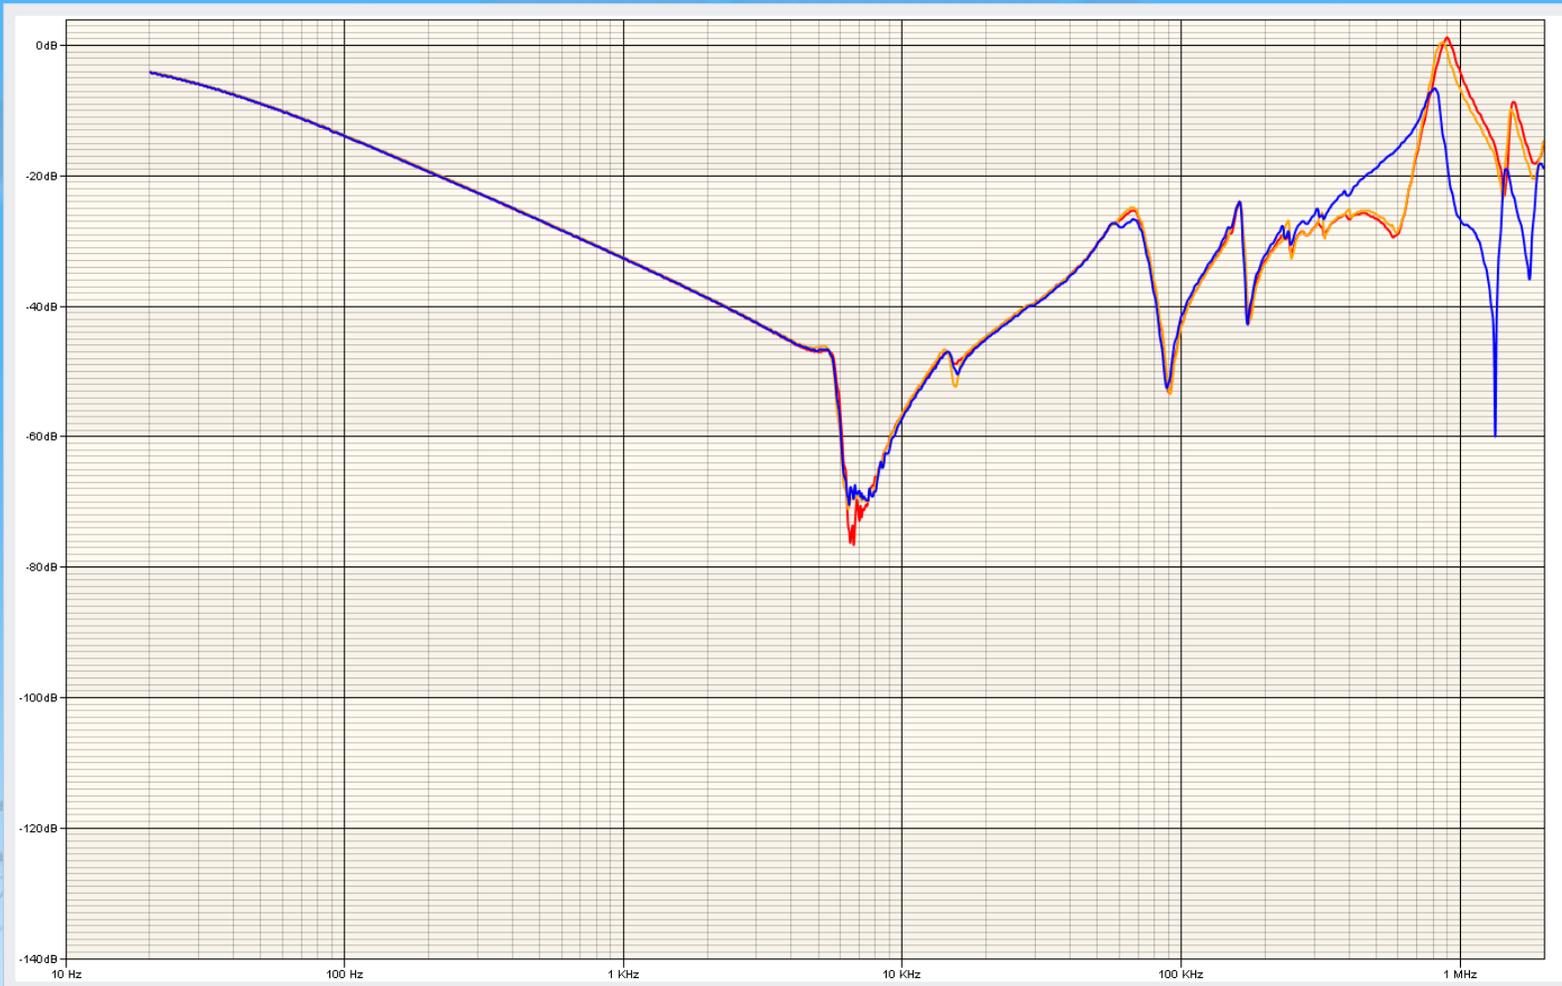
- HV short ckt test indicates the same Condition.
- Blue trace is showing changes In the HF region

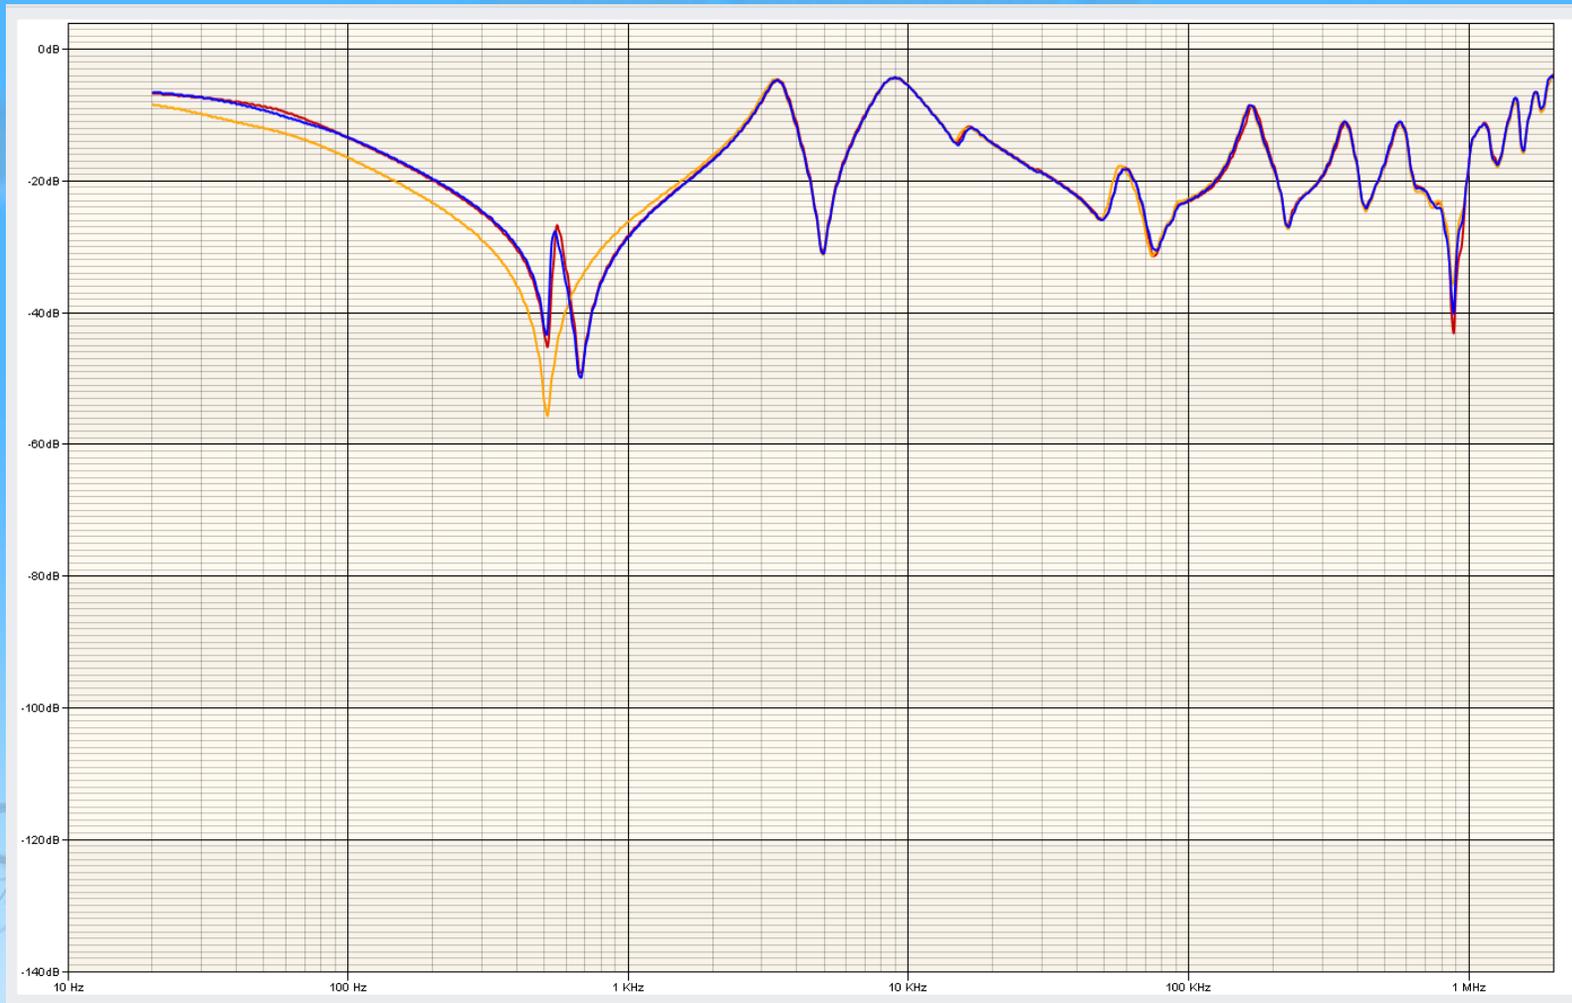
LV Open ckt test

- LV open ckt test indicates no problem on all phases
- LV ckt is ok
- Problem is with high voltage winding termination
- On inspection one of the tap changer lead is dislodged from the support structure

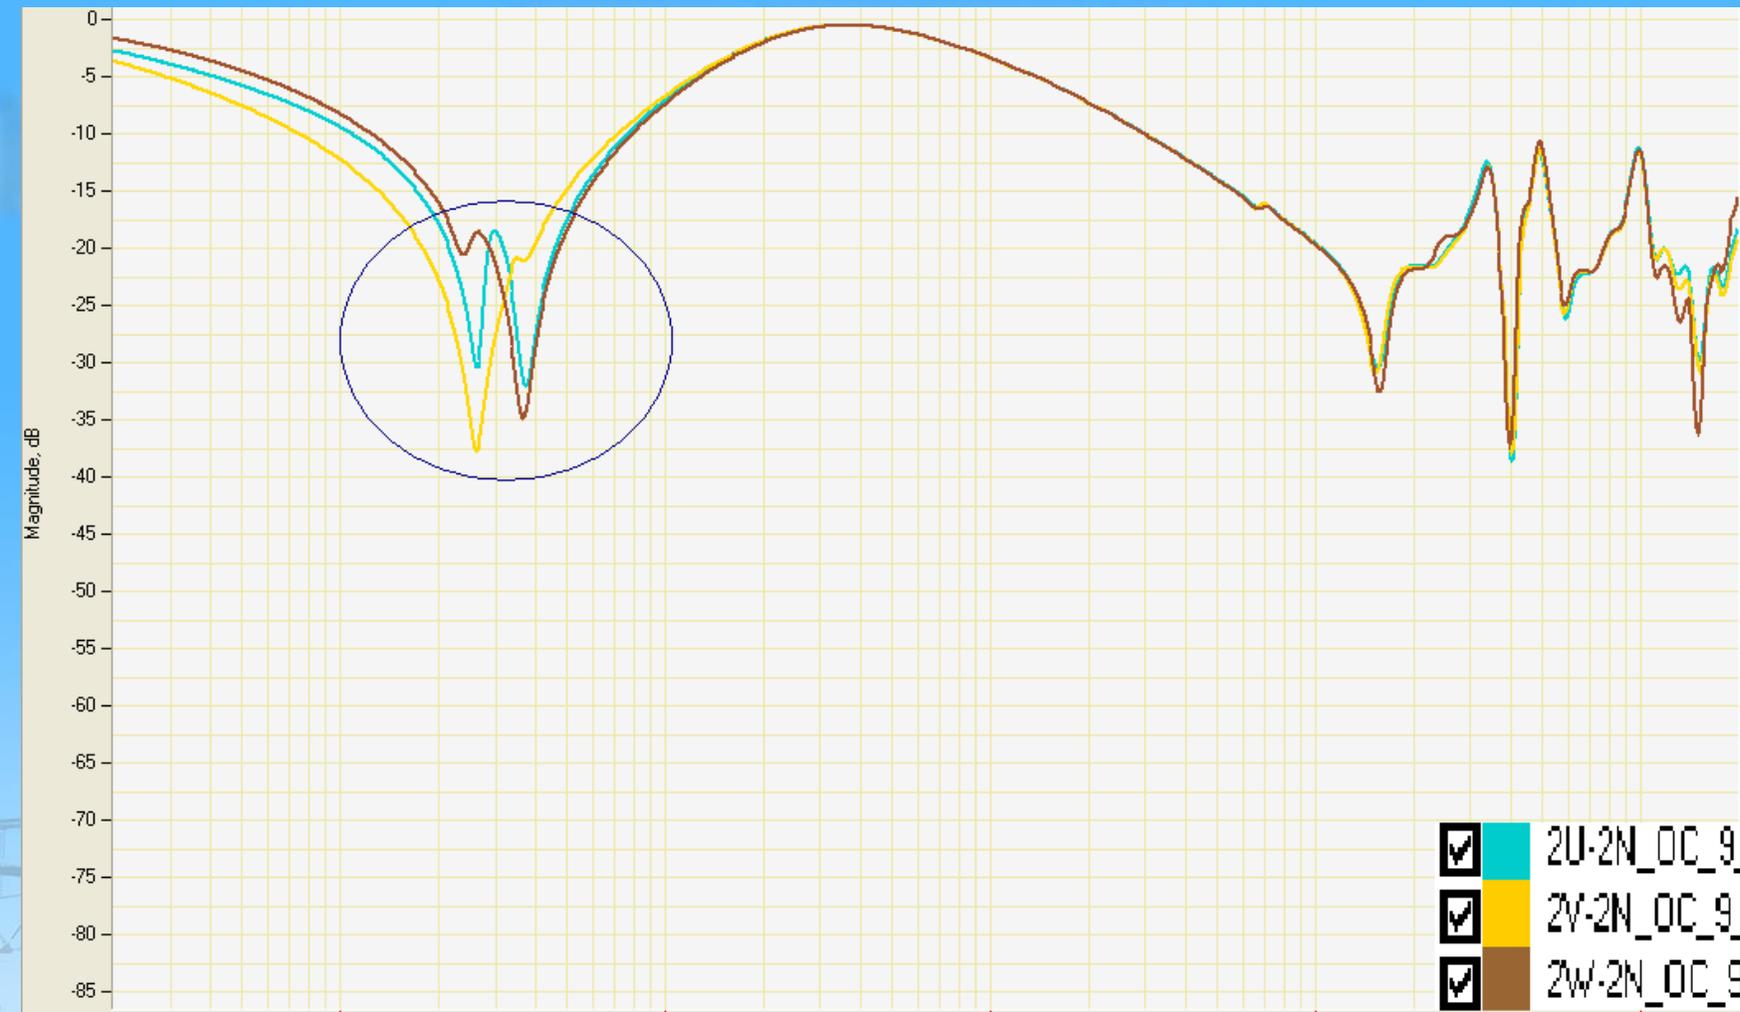
SFRA HV open Ckt Test

- W phase (C phase) indicates the problem
- The shape of the resonance should be like U phase (A phase)
- Resonance peak is missing or reduced in core region
- **Problem with the C phase core**

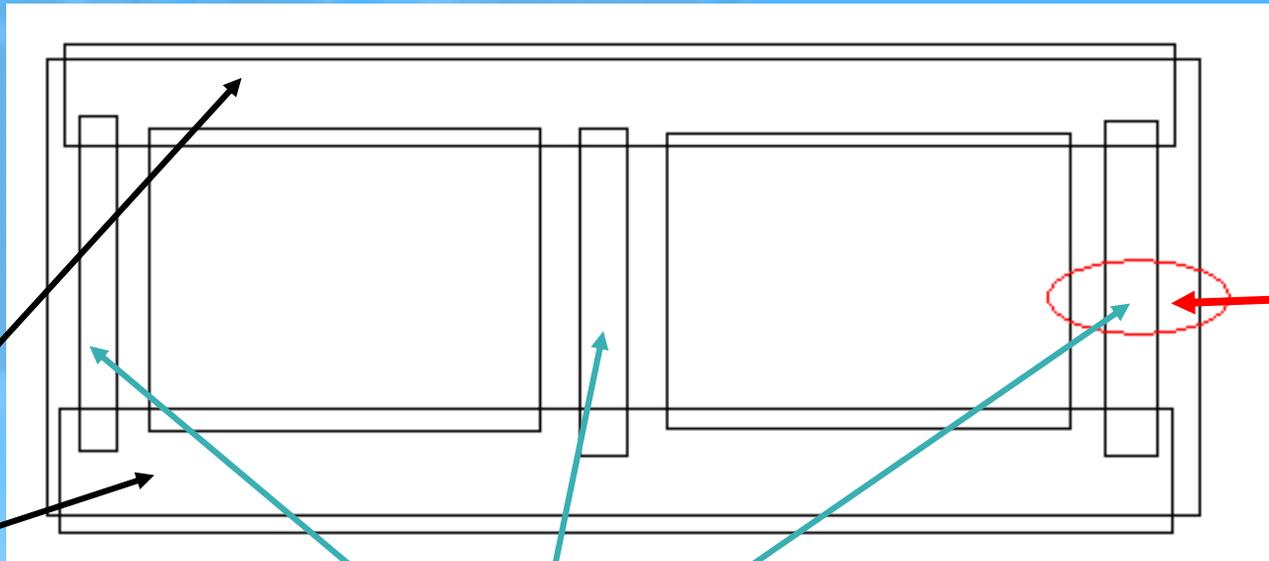
Core Construction

Top and Bottom Frame

Flitch plates

C phase Flitch plate shorts the Core
