Sweep Frequency Response Analyzer

PFRS-25

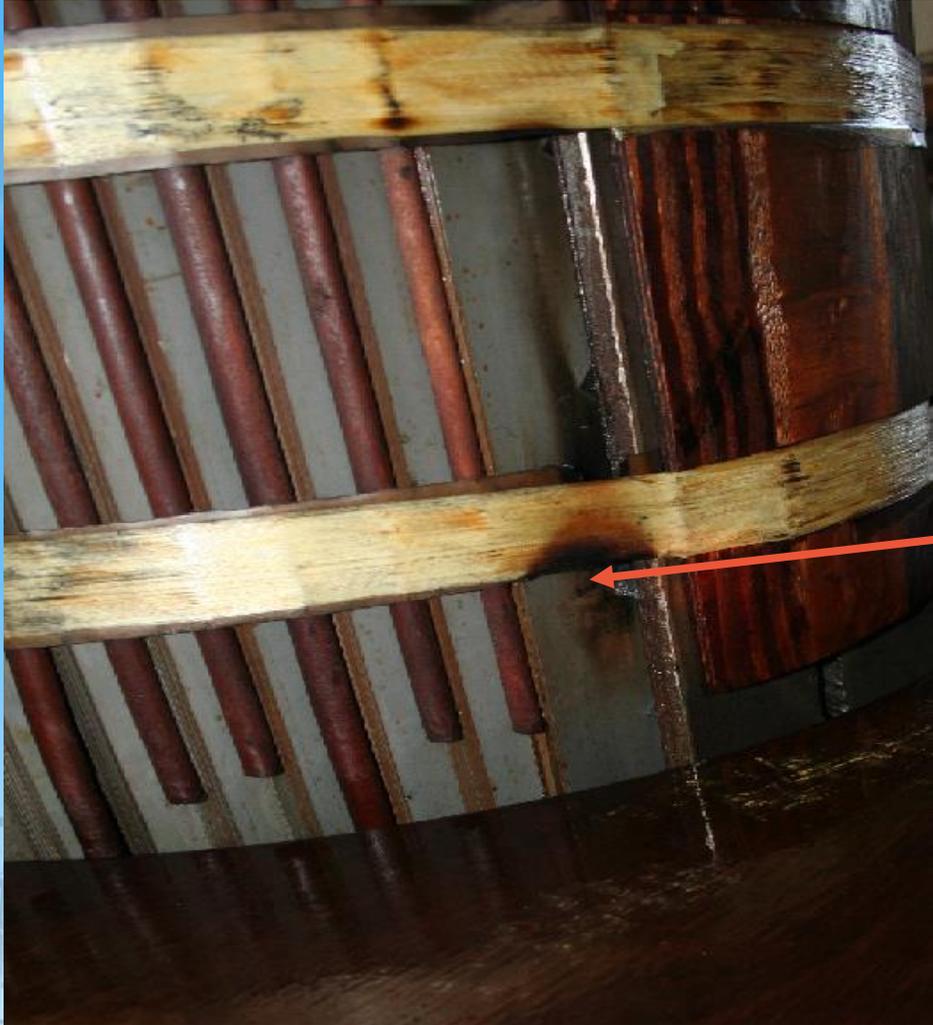
Case Study : Core Ground

Burnt insulation may be due to PD shorts the Flitch plate to the C phase core

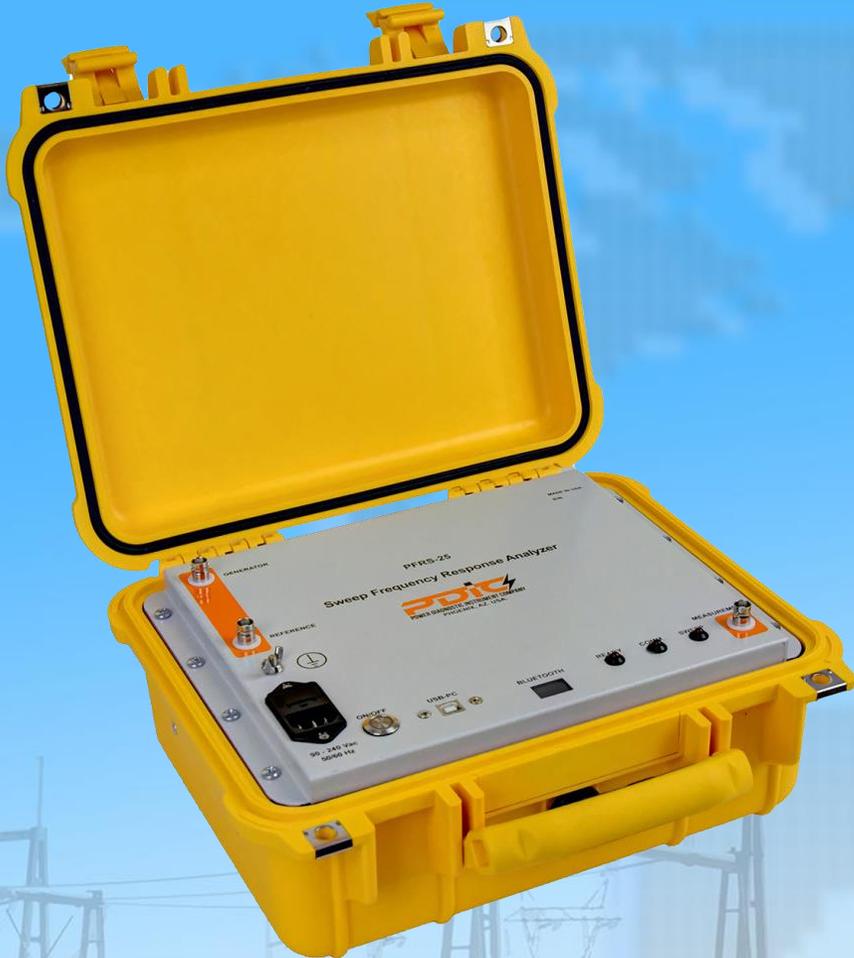
PFRS-25: Outstanding Features

- Faster sweep time
- Field rugged housing
- Built in Battery Back up
- Superior Dynamic Range
- Export import CIGRE standard format
- User Friendly PC software
